INVESTIGATION INTO THE EFFECT OF
DISSIMILAR METAL COUPLING, POTENTIAL,
AND PROCESSING ON THE MODE AND
DISTRIBUTION OF GALVANIC CORROSION
ATTACK ON 5086 ALUMINUM ALLOY
IN SYNTHETIC SEAWATER.

NAVAL POSTGRADUATE SCHOOL

THESIS

September 1977

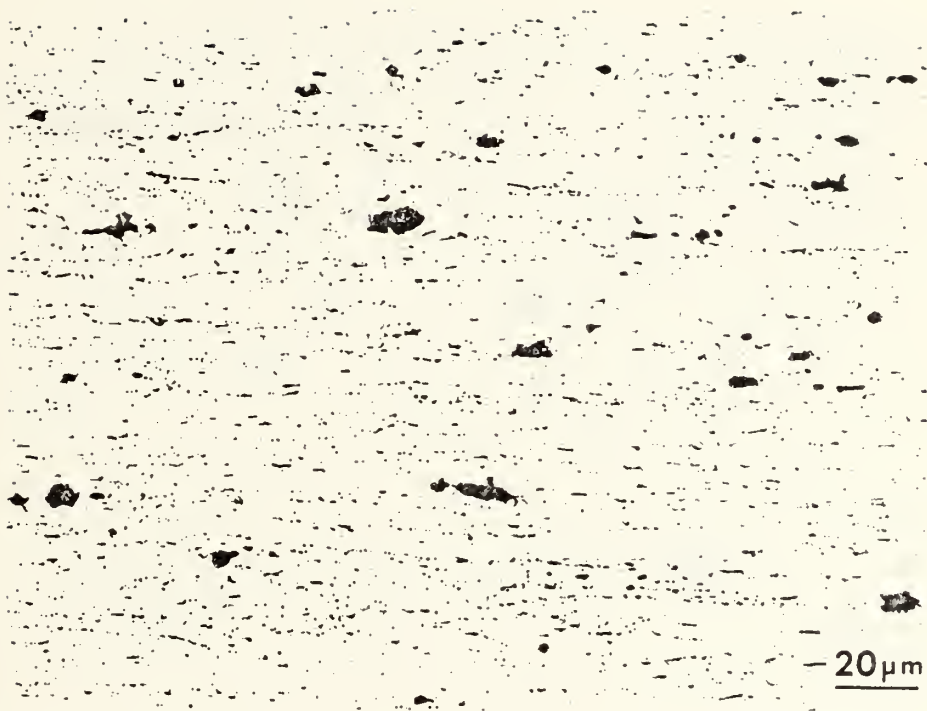
Figure 2. Microstructure of exfoliation resistant 5456-H116 hull plate, 500X [9]

show examples of the typical grain structures of 5456 aluminum alloy in the three different tempers.

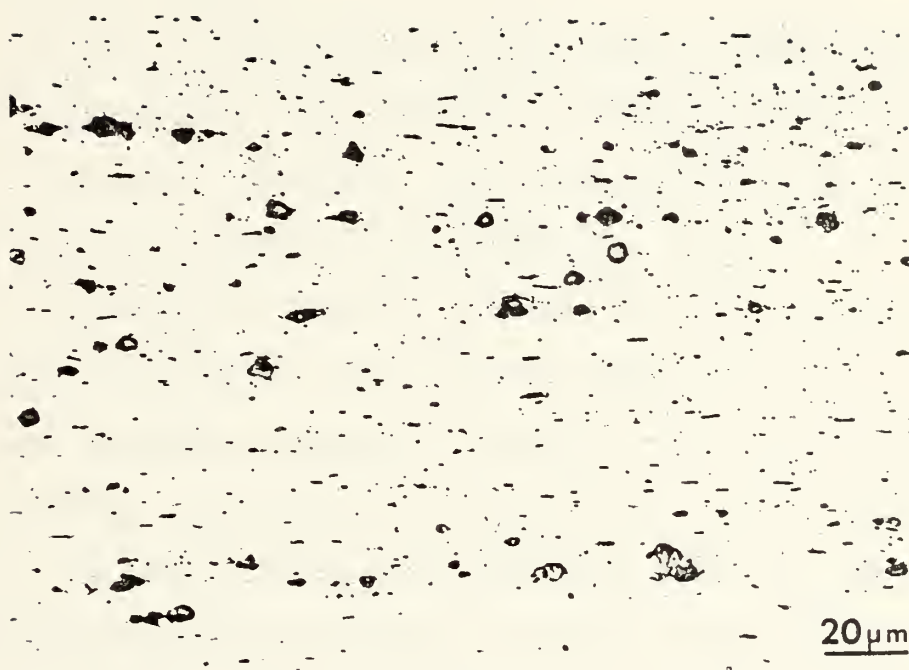
Figure 3. Microstructure of exfoliation resistant 5456-H117 hull plate, 500X [9]

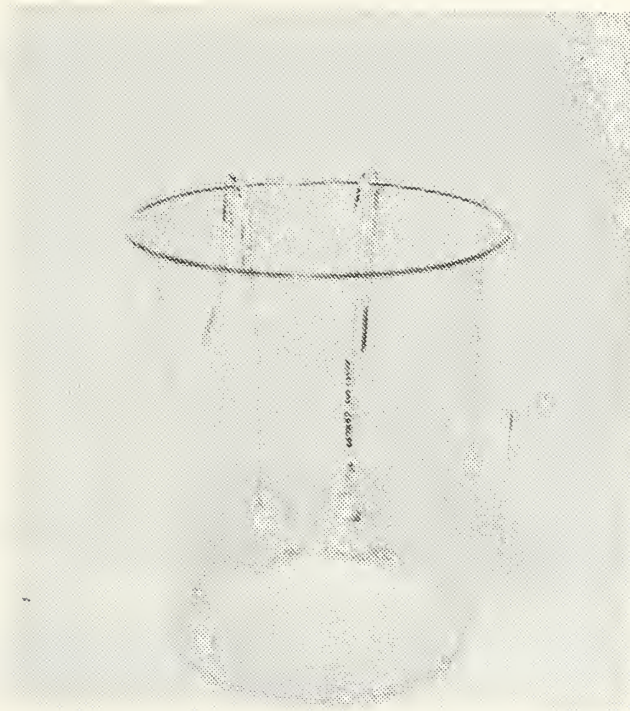
Figure 11. Arrangement of corrosion cell used to measure galvanic current density

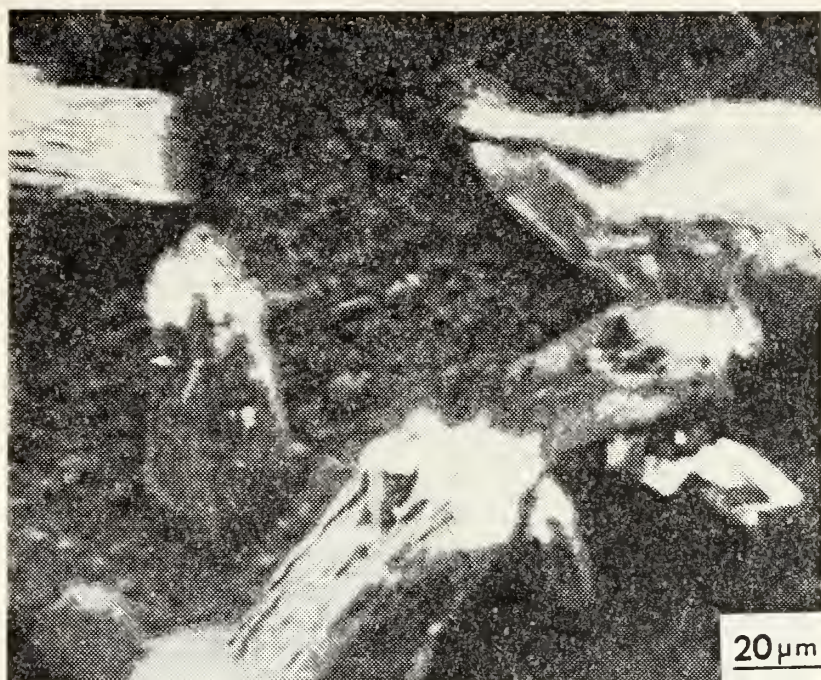
Figure 35. Precipitate formations on brass in Brass/H32 couple exposed for eight weeks, (a) 550X (SEM), (b) 550X PGT dot mapping of same area using characteristic calcium X-ray wavelength.

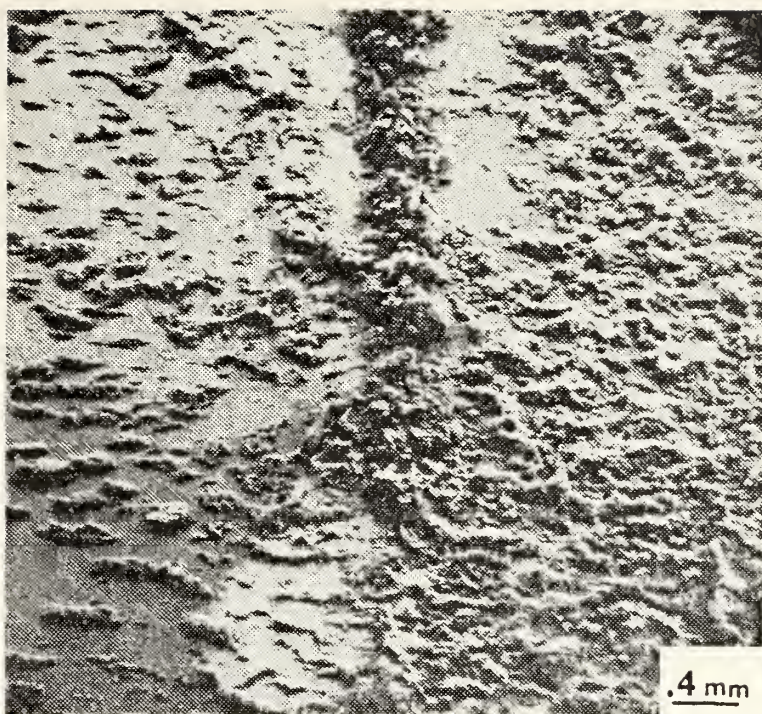
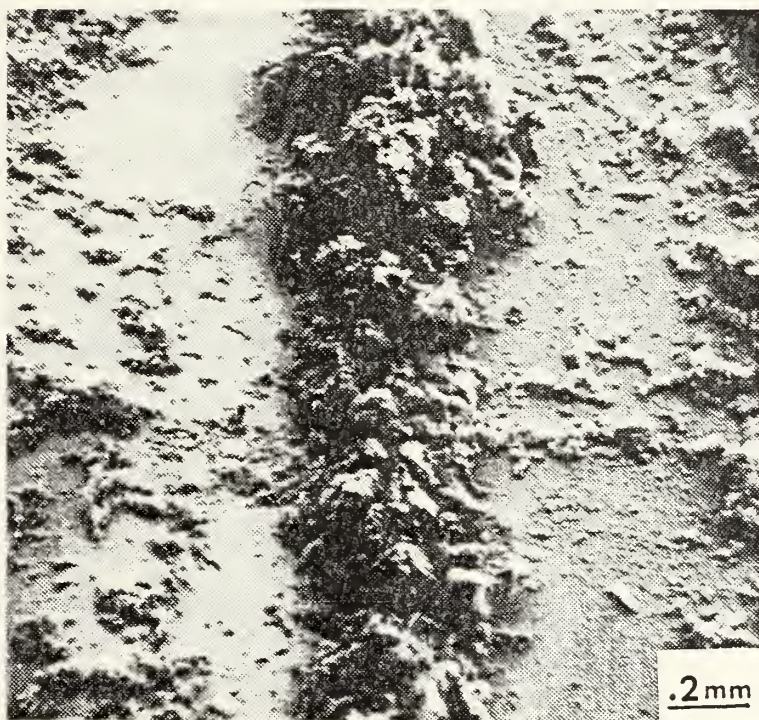
Figure 48. Cathode/anode joint area on TI/H32 couple exposed for three weeks, (a) 22X (SEM), (b) 52X (SEM).

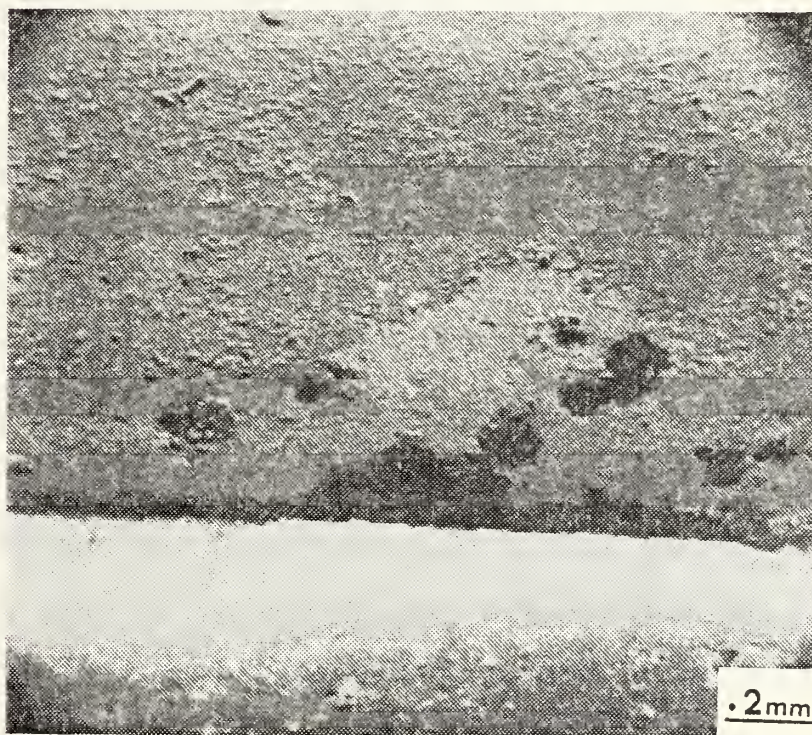
Figure 51. Corrosive attack on (a) H32 in Steel/H32 couple exposed for three weeks, 55X (SEM), (b) H32 in Brass/H32 couple exposed for eight weeks, 55X (SEM).

In Figure 51(b), the existence of a raised edge of Al (on the left side along the Al/plastic interface) is illustrated, the probable cause of the concentrated attack at the Al/plastic interface was noted earlier. As previously noted, considerable effort had gone into designing and
